Memorandum

To: Mike Zimmerman
EPA-OSC
From: Mike Sullivan
TAT Region 8
Date: 8/6/92
Subject: Inspection of the Tailings Dam at Richardson Flats T08-9204-015.

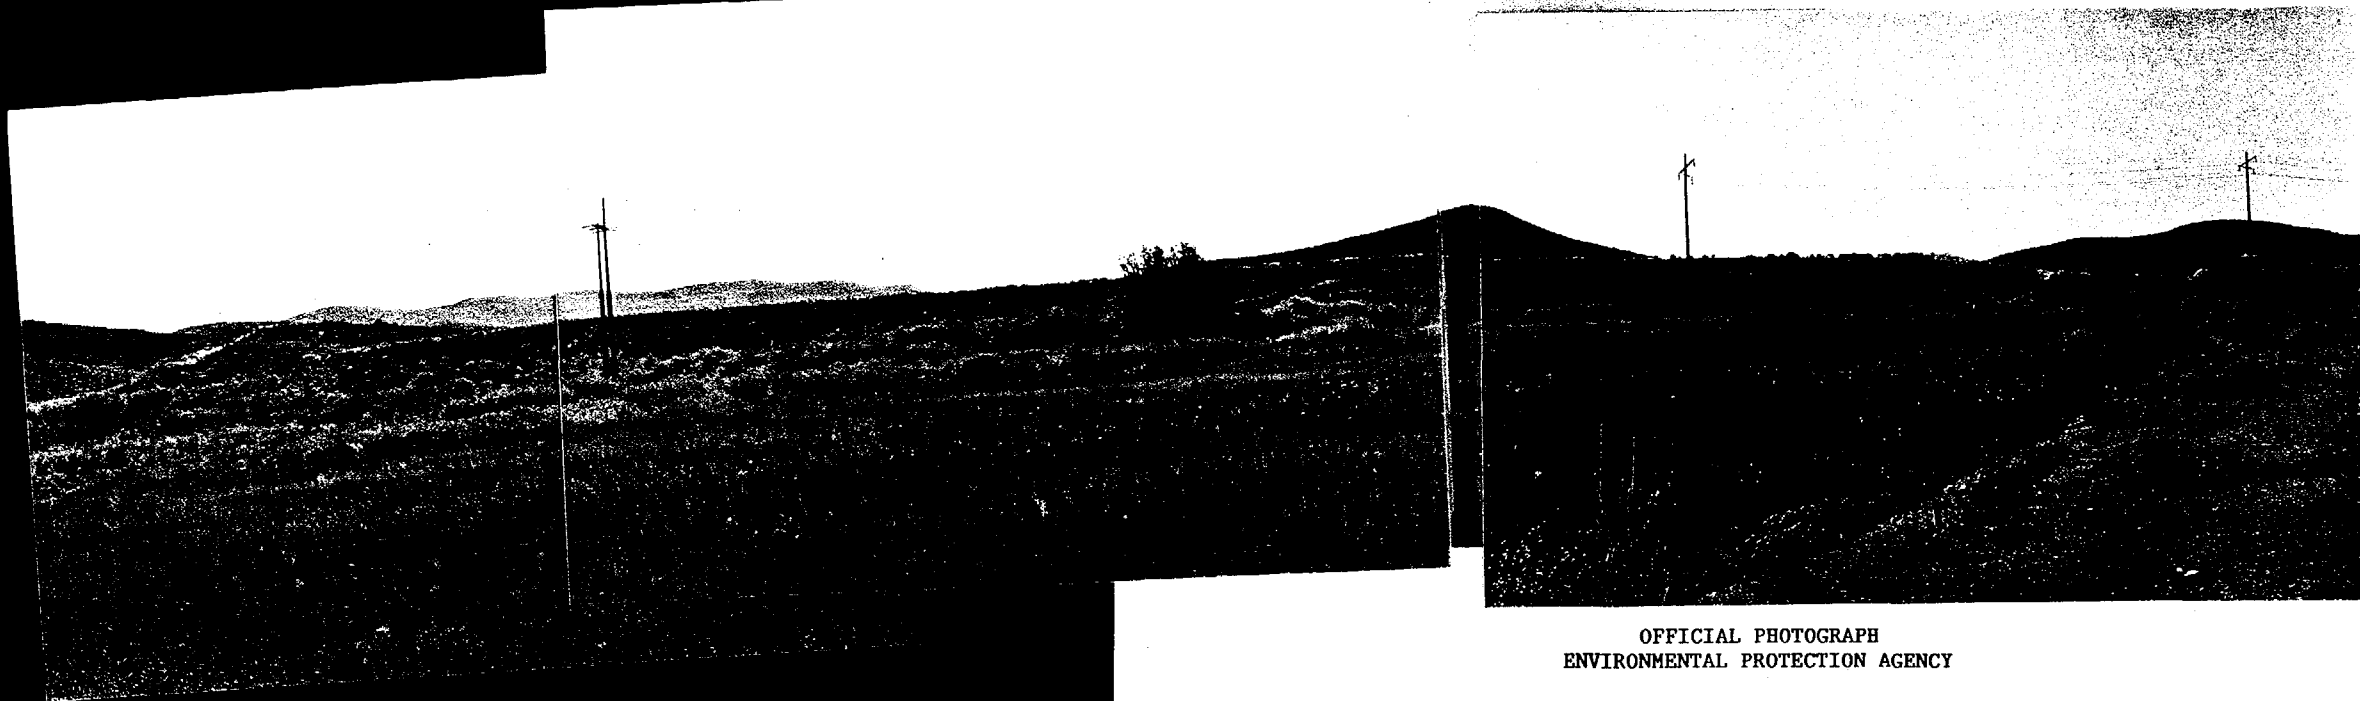
The main embankment is about 30 feet high with a slope length of approximately 50 feet. The main embankment is oversteep lying at 1.0:1.0 to 1.5:1.0 (run:rise). Approximately 6" of fine dry sand, possibly windblown tailings, was noted under a 3" topsoil cover layer on the downstream face of the embankment. The sand has no

strength and will erode quickly if exposed. A 35% to 50% grass cover was on most of the embankment which will help in erosion control. No cracking was evident on the embankment, although the sand layer would tend to hide any small cracking. Also, no bending (bulging) was noted on the embankment.

Subject: Panorama of main embankment from west and downstream
